# Vessel Mooring Study - Boca Chica Harbor - Monroe County, Florida

## Final Project Report

May 17, 2011

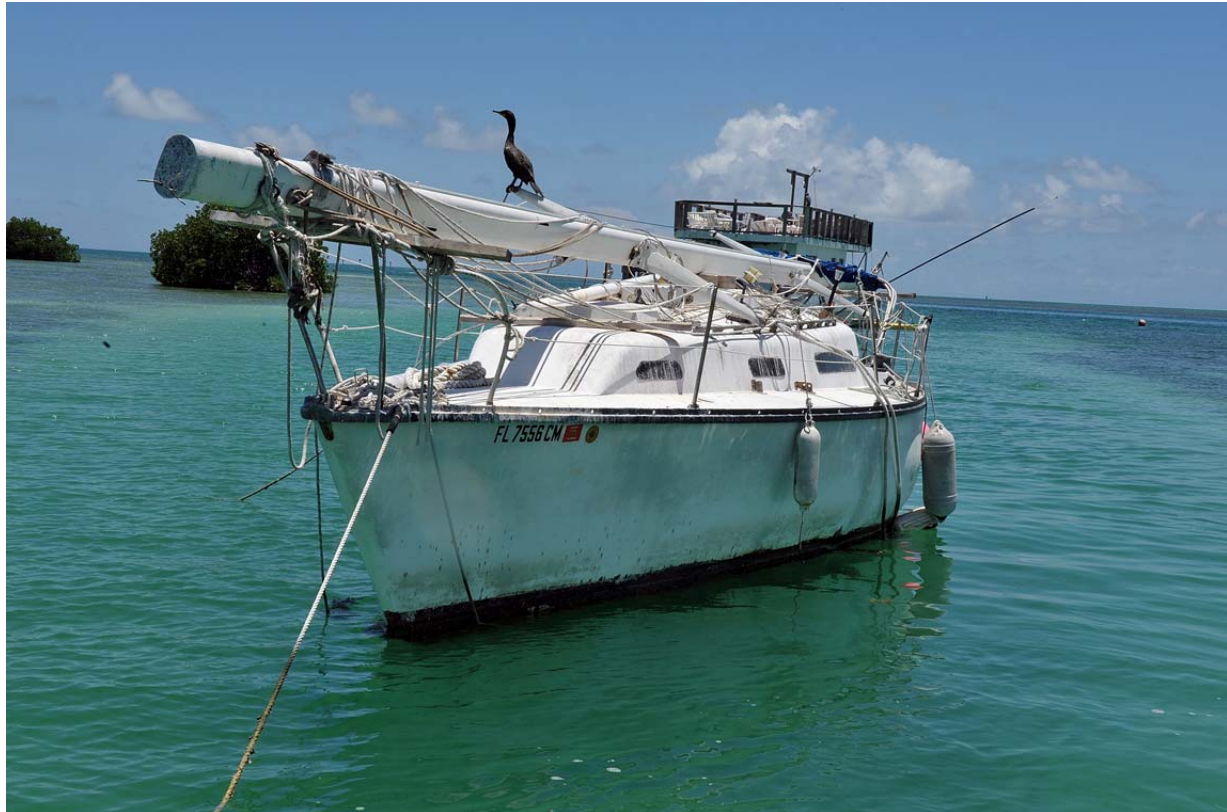
Photo of a stored sailboat. This vessel is not being used as a liveaboard. Seabirds commonly take up residence on stored vessels that are not actively maintained, fouling the vessel with guano.

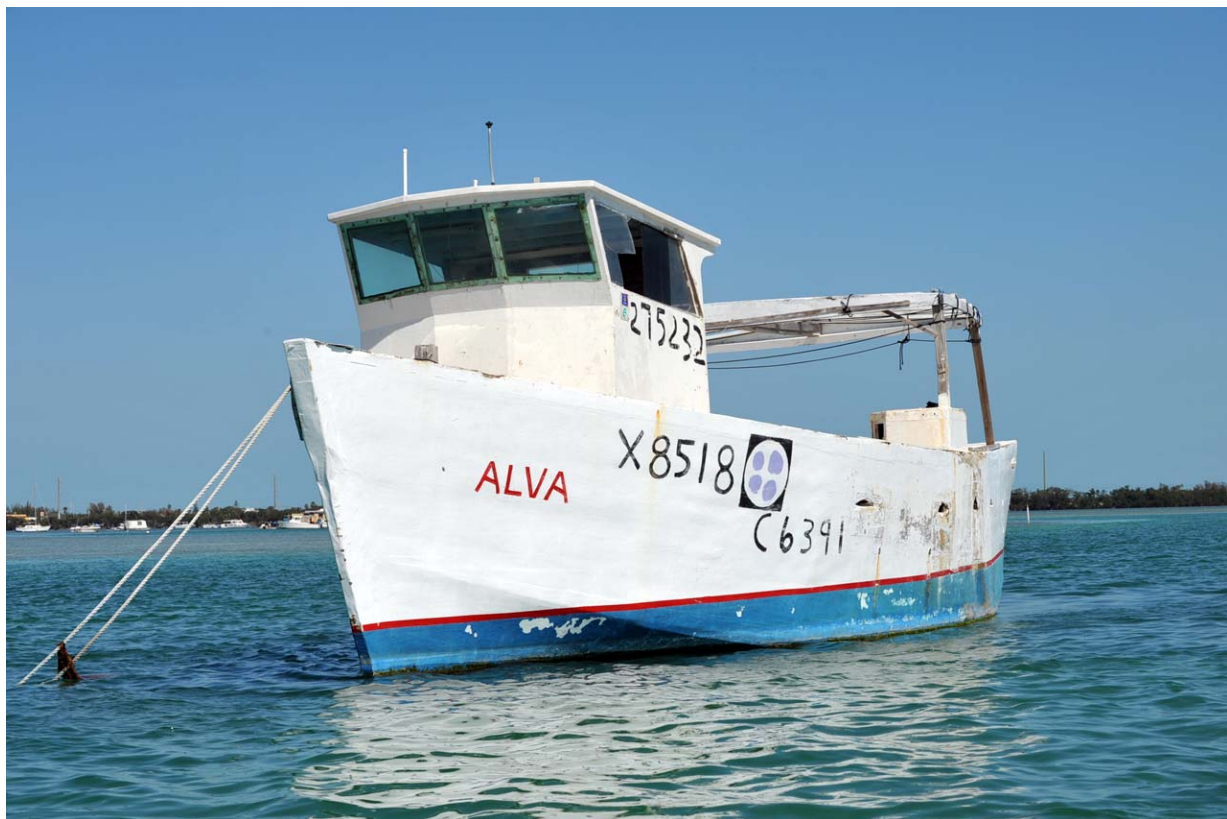
Photo of a stored powerboat. This vessel is not being used as a liveaboard or actively being used for fishing. The vessel is grounded on a shallow seagrass bed (note boot top well above waterline).

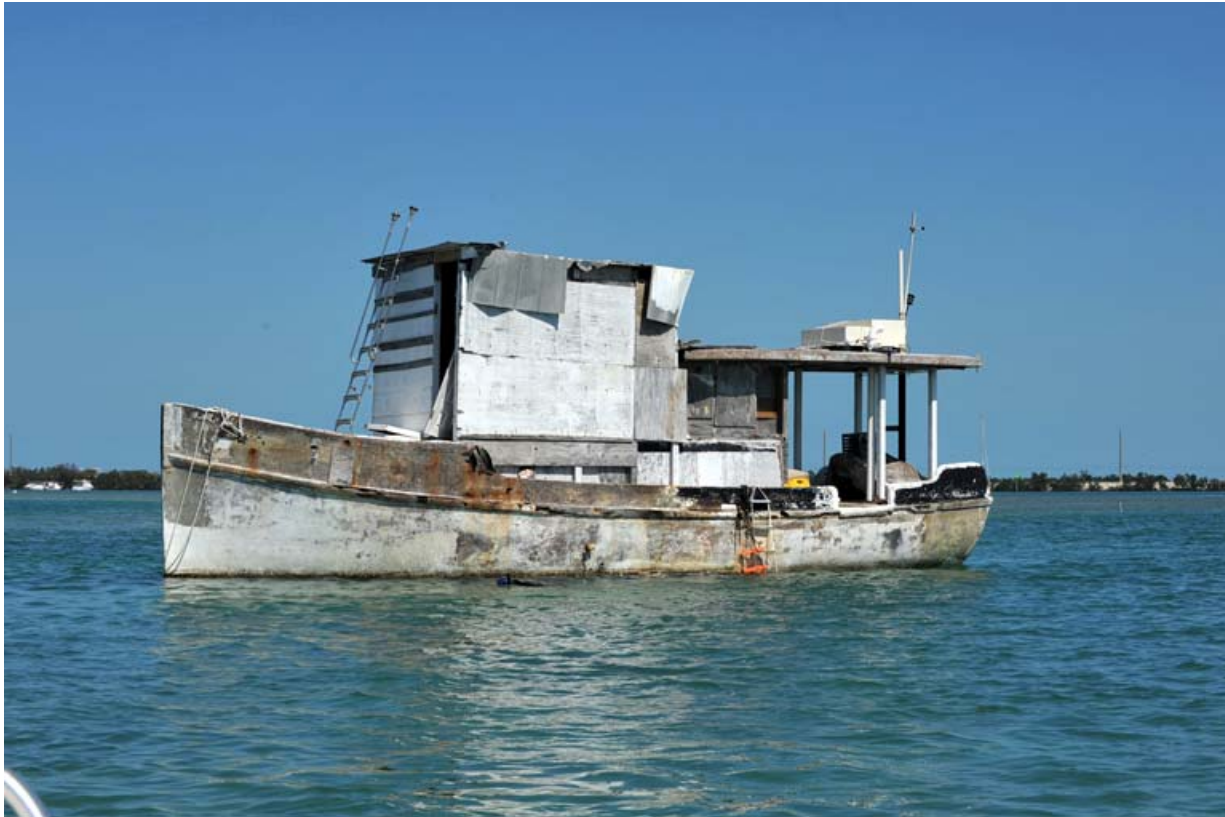
Photo of a poorly-maintained liveaboard powerboat. Vessels in poor condition typically lack operating propulsion and are at-risk for dereliction.

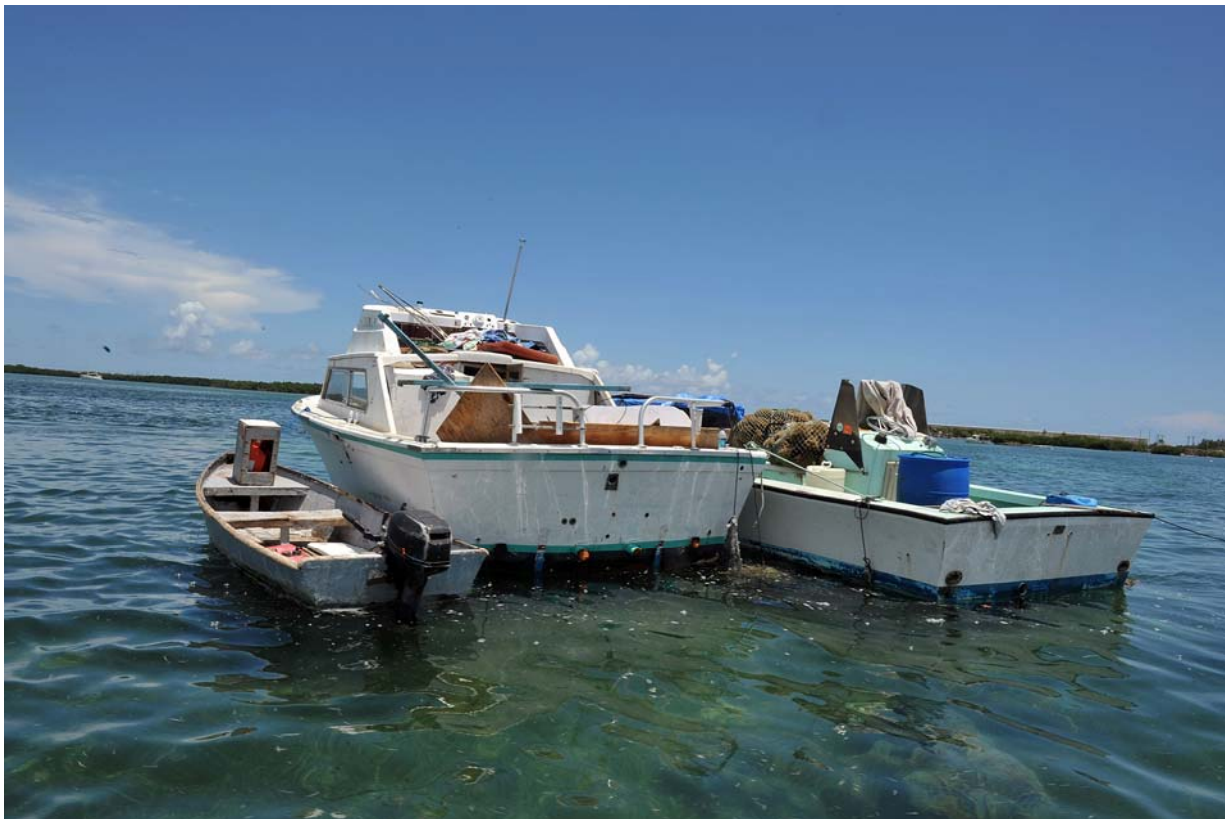
Photo of a poorly-maintained stored powerboat that is being used as a storage facility to support a commercial sponge fishing operation.

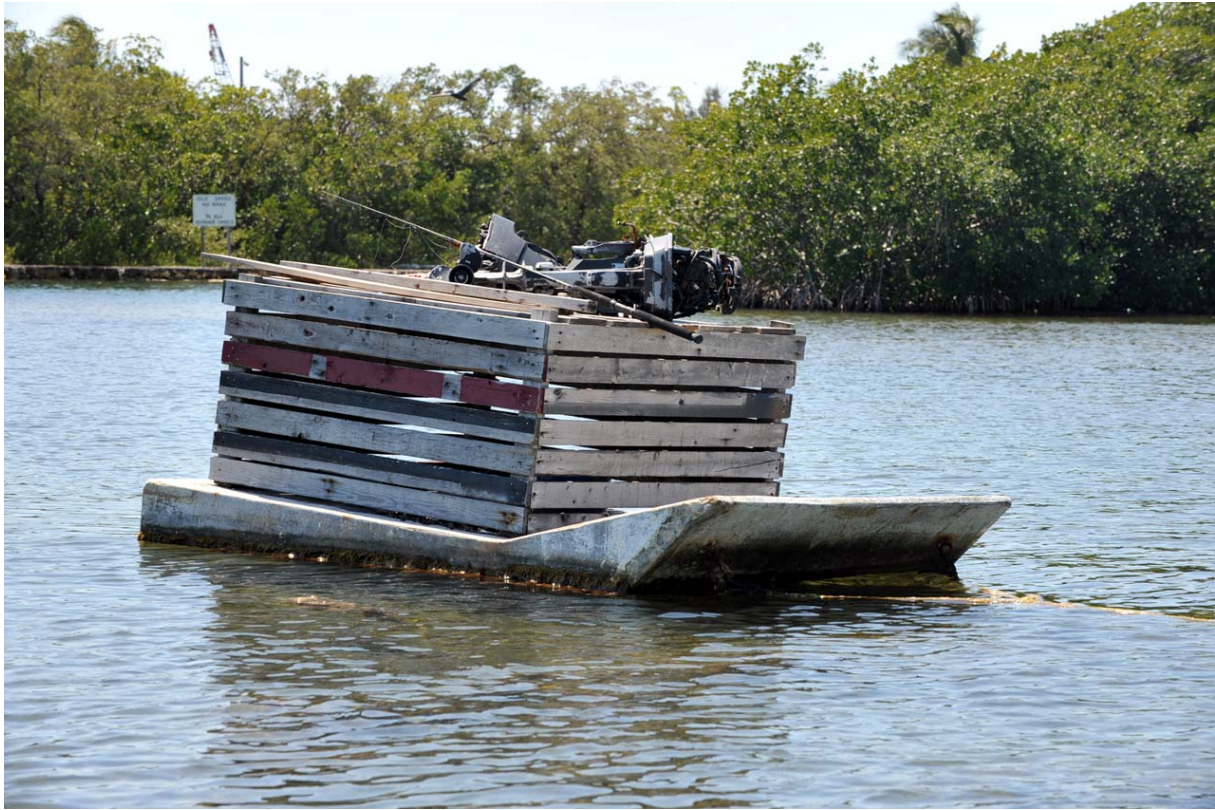
Photo of a floating platform being used for storage. The derelict outboard motor visible in the photo is a likely candidate for a mooring.

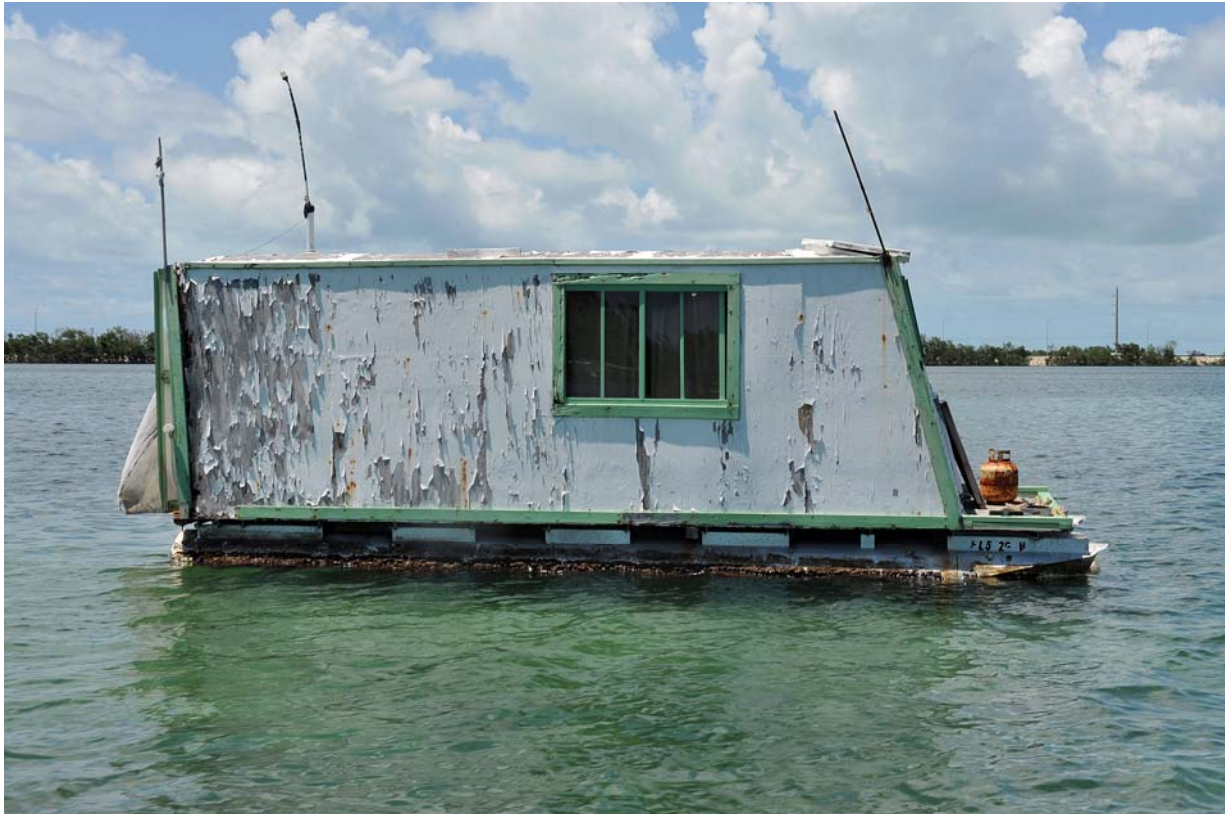
Photo of a floating platform that is used as a domicile. This vessel was in active use at the beginning of the survey, but was later abandoned.

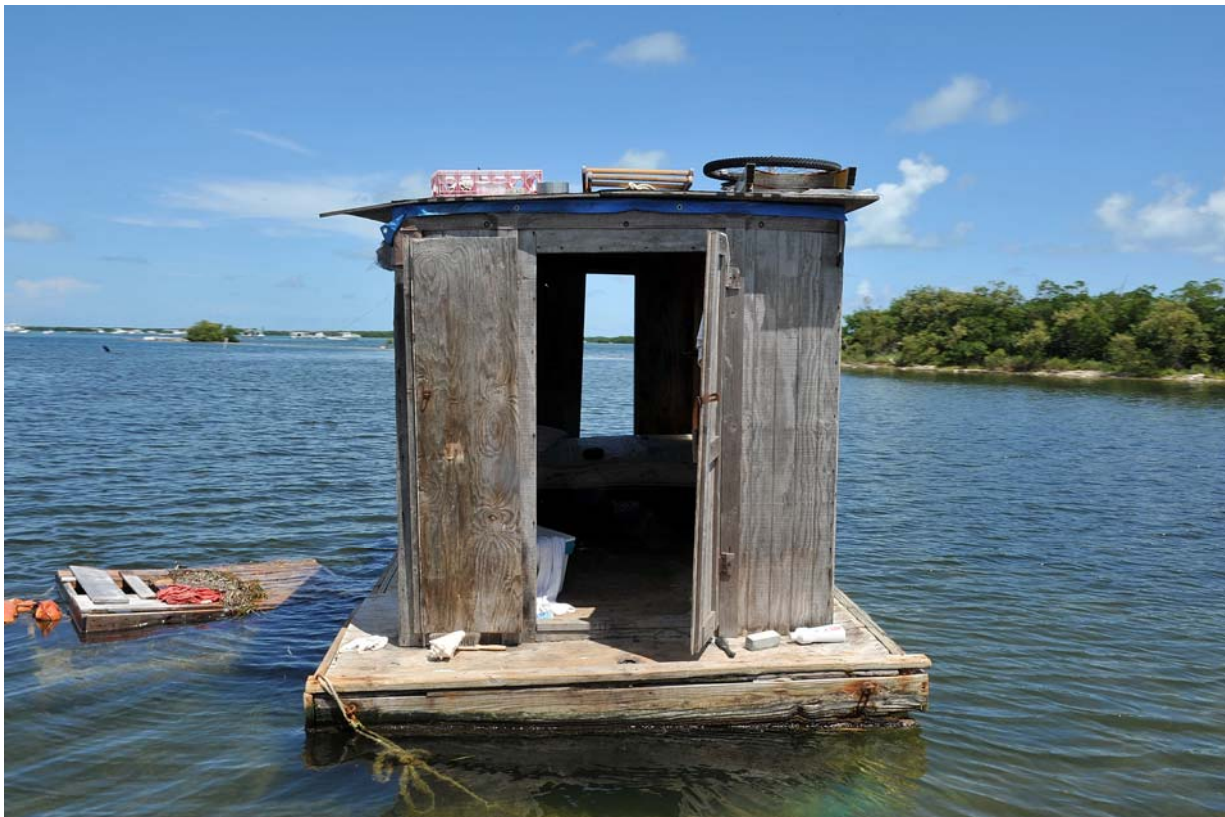
Photo of a floating platform that is used as a domicile. This vessel was in active use at the beginning of the survey, but was later abandoned. Note the derelict/sunk floating platform moored to this platform.

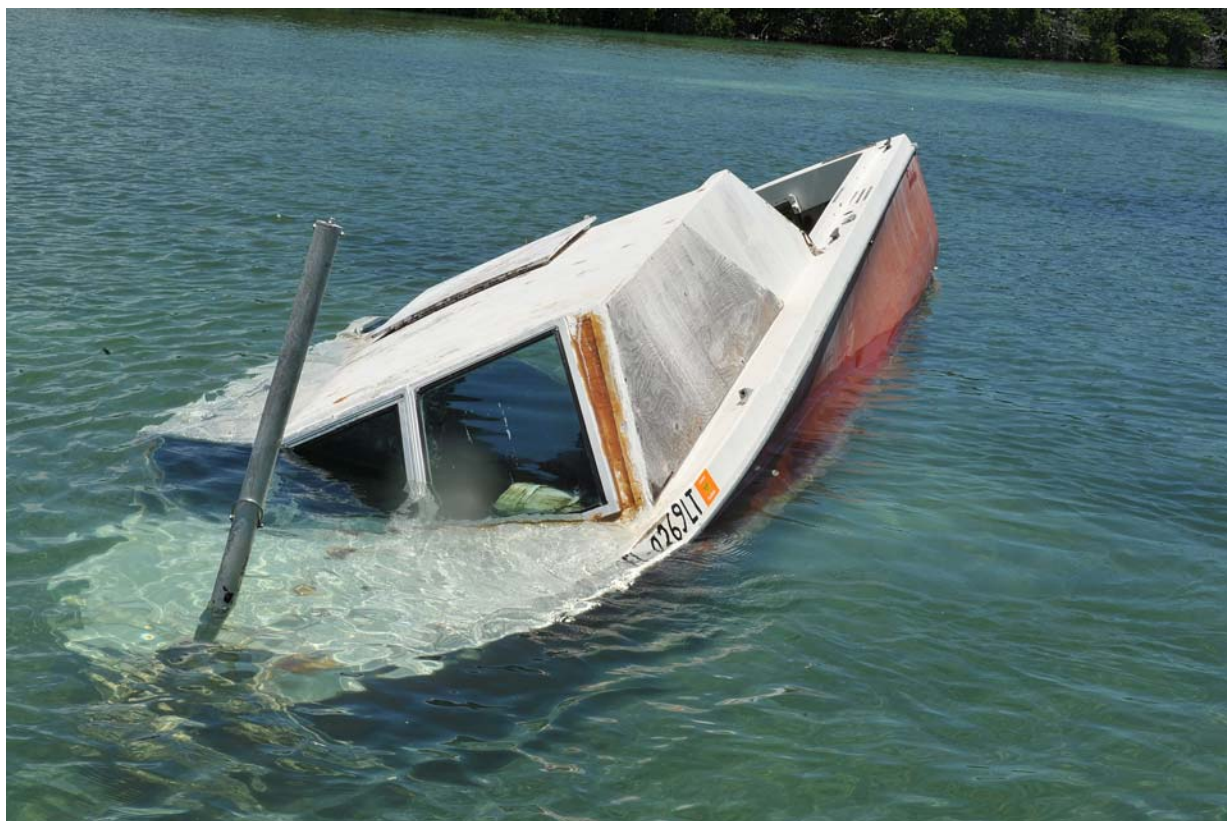
Photo of a derelict vessel sunk in a shallow seagrass flat. Vessels grounded or sunk in shallow seagrass beds cause a loss of seagrass habitat from shading and scour.

***Recommendation:*** Monroe County (and other marine resource management agencies) should protect shallow seagrass habitats by prohibiting long-term mooring of vessels in areas where seagrass habitat damage is anticipated.

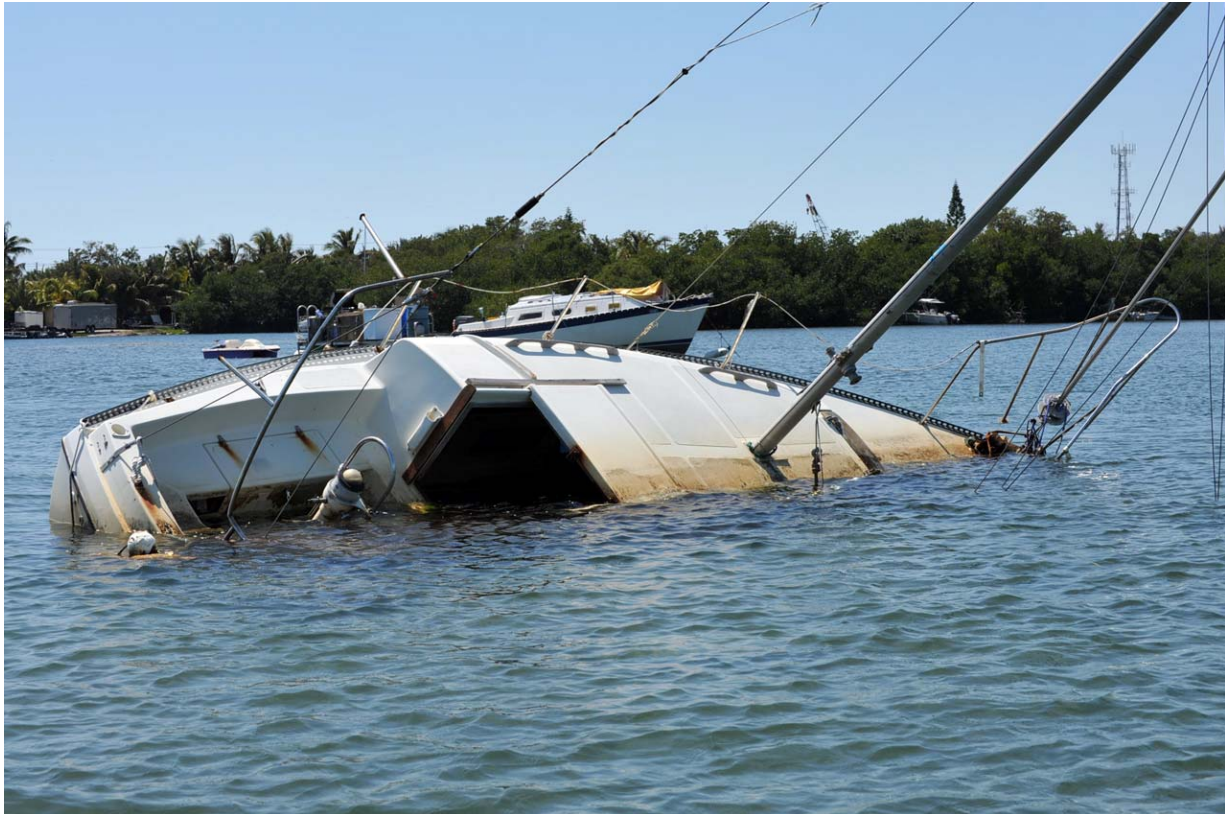
Photo of a derelict vessel sunk in a shallow seagrass flat. Vessels grounded or sunk in shallow seagrass beds cause a loss of seagrass habitat from shading and scour.

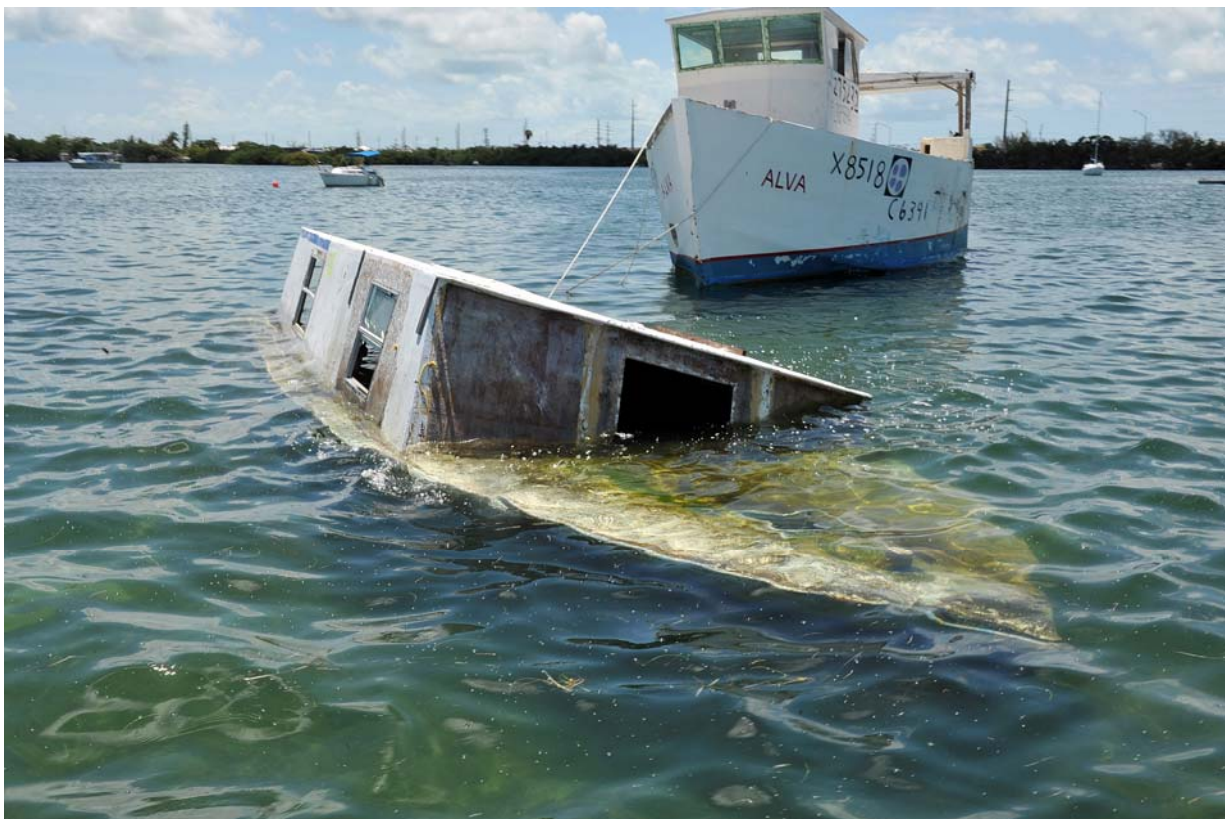
Photo of a derelict vessel sunk in a shallow seagrass flat with a grounded vessel moored to it. Vessels grounded or sunk in shallow seagrass beds cause a loss of seagrass habitat from shading and scour.

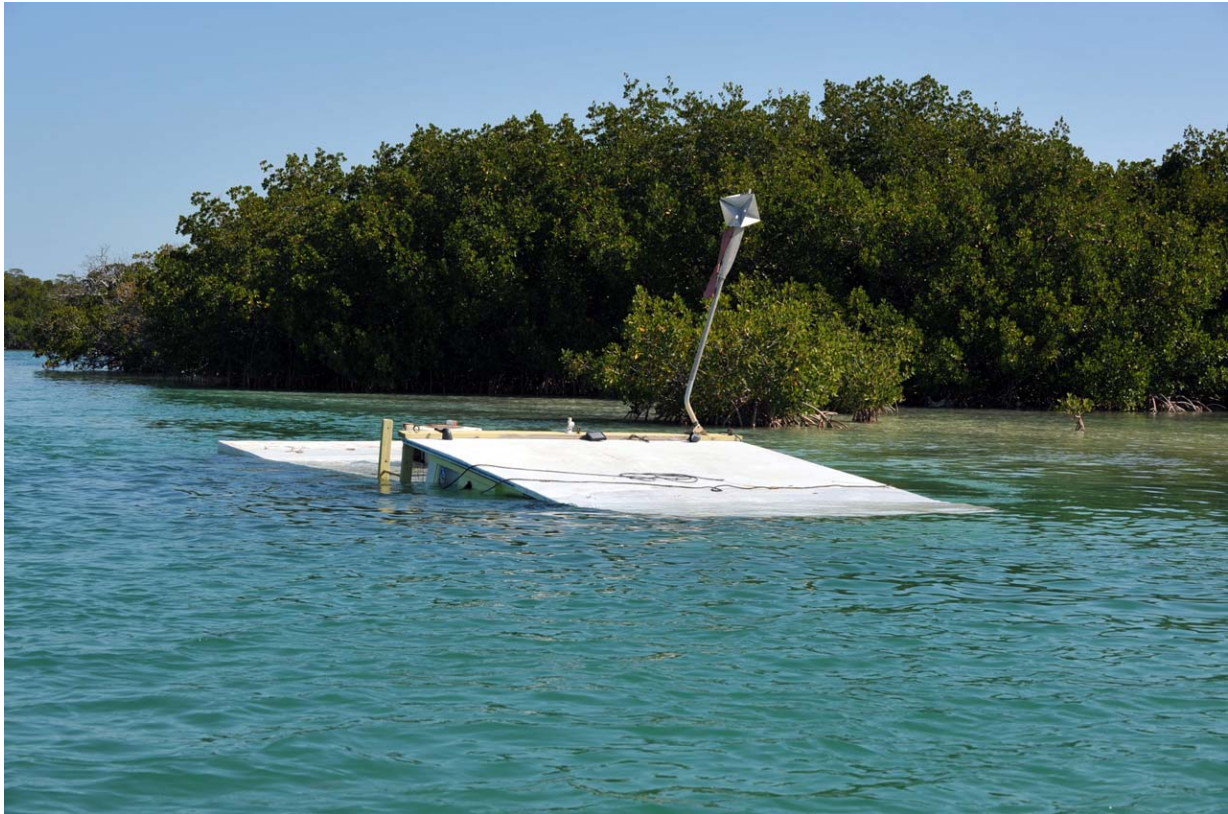
Photo of a derelict vessel sunk in a shallow seagrass flat. Vessels grounded or sunk in shallow seagrass beds cause a loss of seagrass habitat from shading and scour. This vessel is a large houseboat.

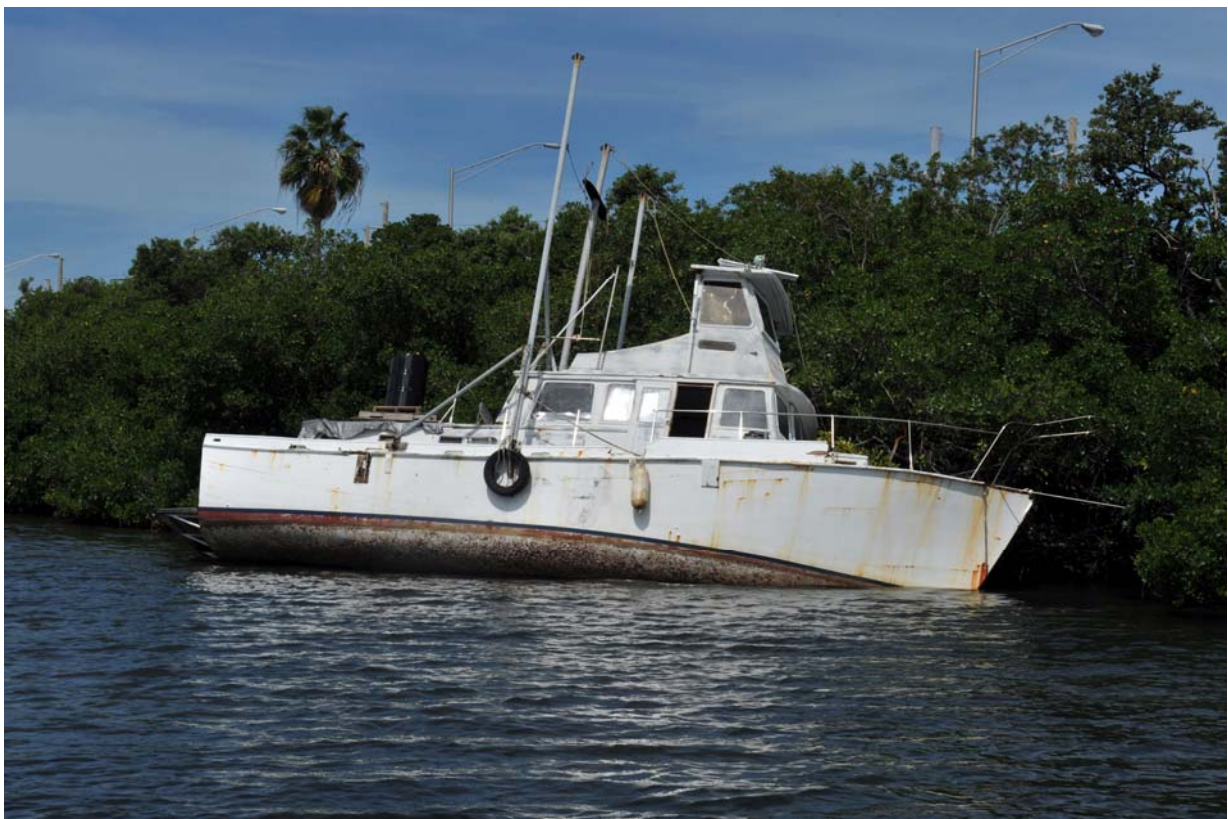
Photo of a derelict vessel grounded in a mangrove shoreline and shallow seagrass flat. Vessels grounded or sunk in shallow seagrass beds cause a loss of seagrass habitat from shading and scour.

***Recommendation:*** Monroe County (and other marine resource management agencies) should develop a program to prevent derelict vessels from accumulating in anchoring areas throughout the Keys. A program that requires vessel owners to register vessels that are anchored over publicly-owned submerged lands would assist regulatory agencies in identifying owners of vessels and documenting the status of anchored vessels. Vessels that do not have proper documentation of ownership or vessels that are deemed prone to dereliction could be addressed before they become derelict. It should be noted that Monroe County and resource management partners (e.g. FWC, NOAA/FNKMMS) are well aware of the problems associated with derelict vessels and are actively engaged in addressing the problem throughout the Keys.

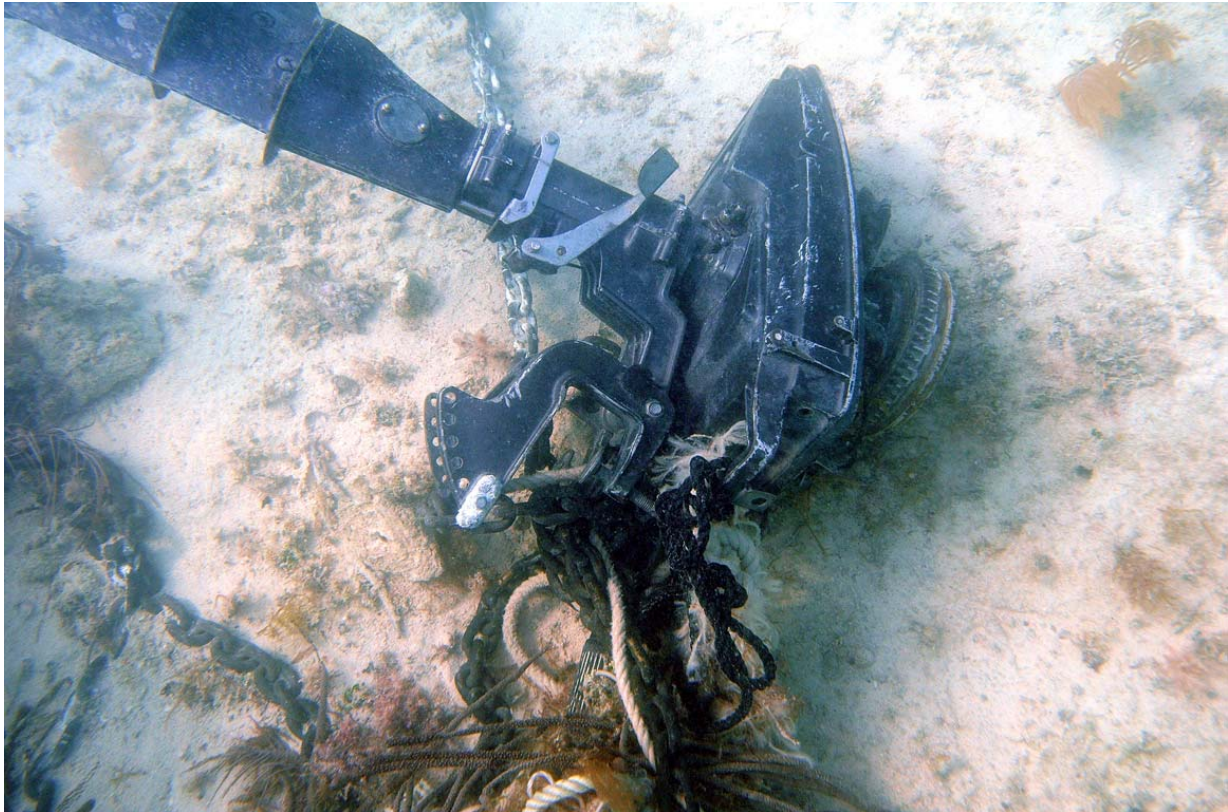
Photo of a typical debris-constructed mooring in hardbottom habitat. Various motors including outboards and large-block vehicular motors were common mooring devices.

***Recommendation:*** Monroe County (and other marine resource management agencies) should protect hardbottom habitat by requiring vessels to utilize appropriate mooring devices. The use of ad-hoc mooring devices in hardbottom areas should be prohibited.

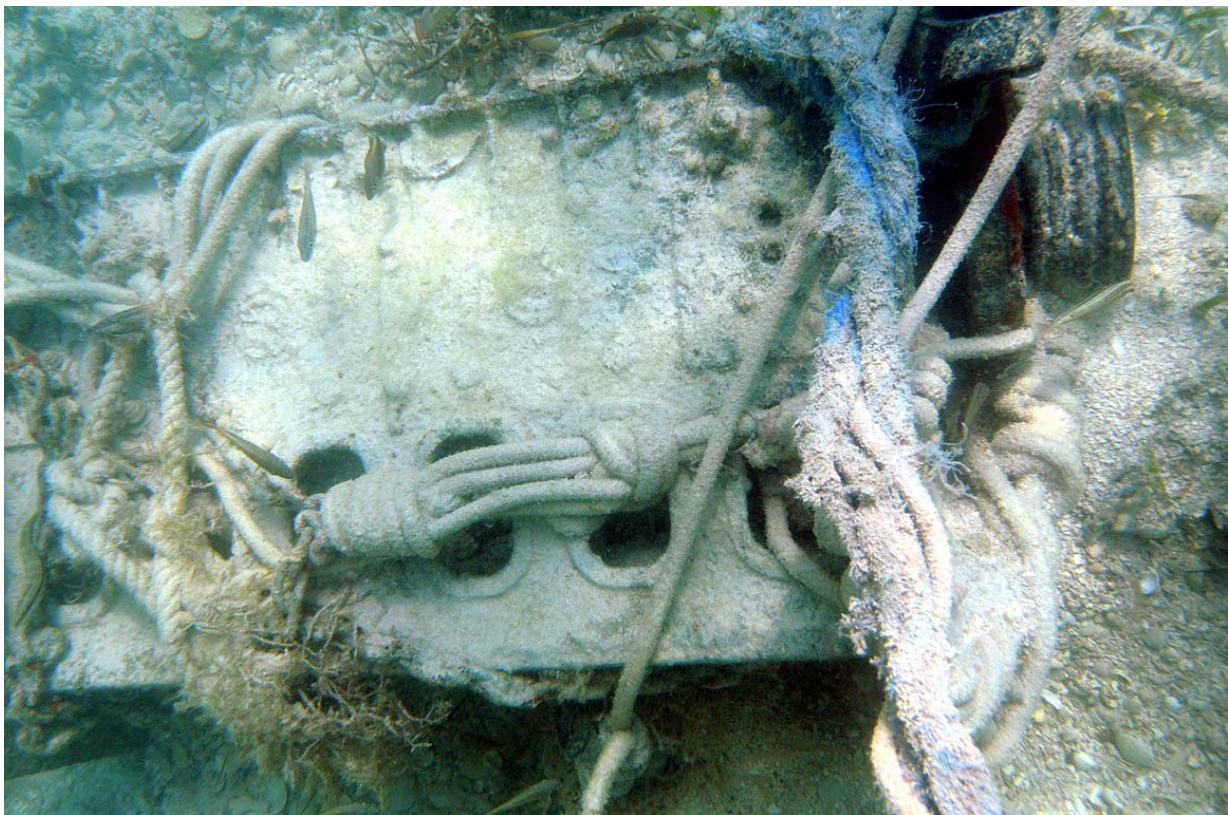
Photo of a typical debris-constructed mooring in hardbottom habitat. Various motors including outboards and large-block vehicular motors were common mooring devices.

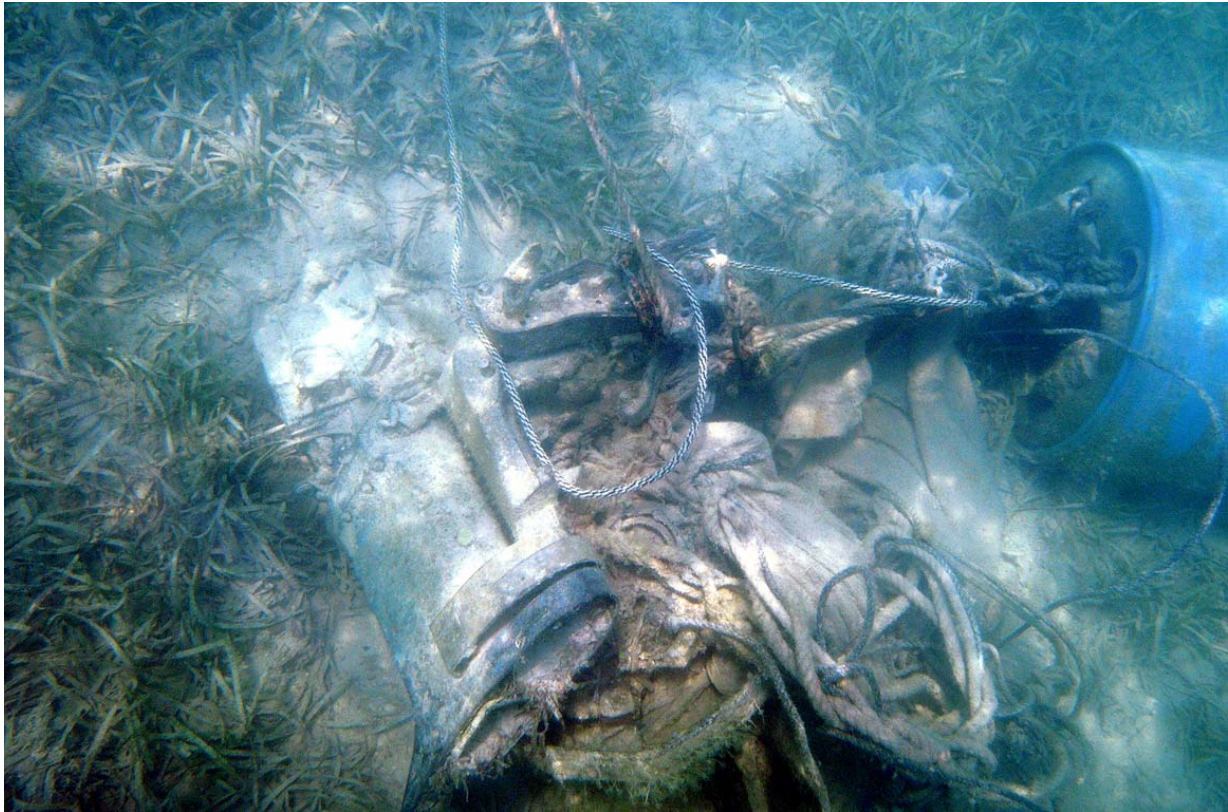
Photo of a typical debris-constructed mooring in seagrass habitat. The concrete-filled blue drums is also a common mooring device seen throughout the mooring.

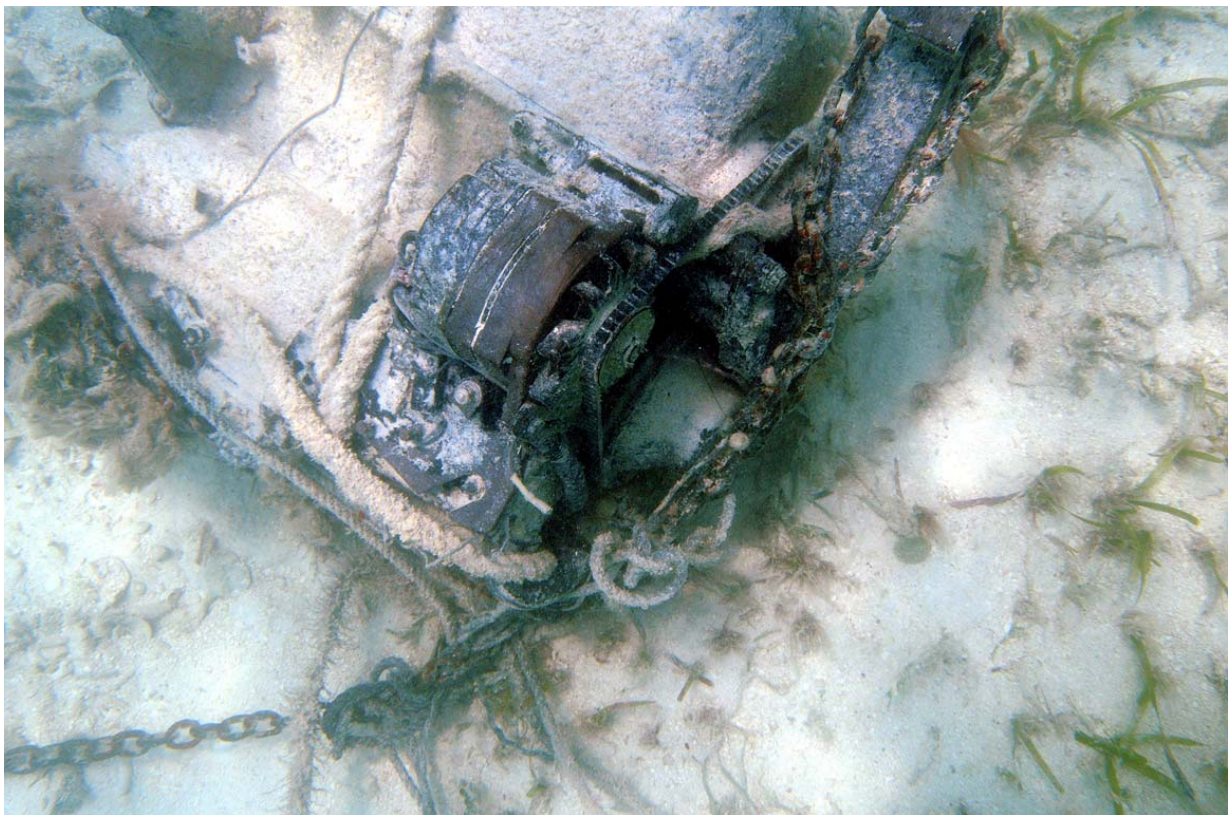
Photo of a typical debris-constructed mooring in seagrass habitat. Various motors including outboards and large-block vehicular motors were common mooring devices.

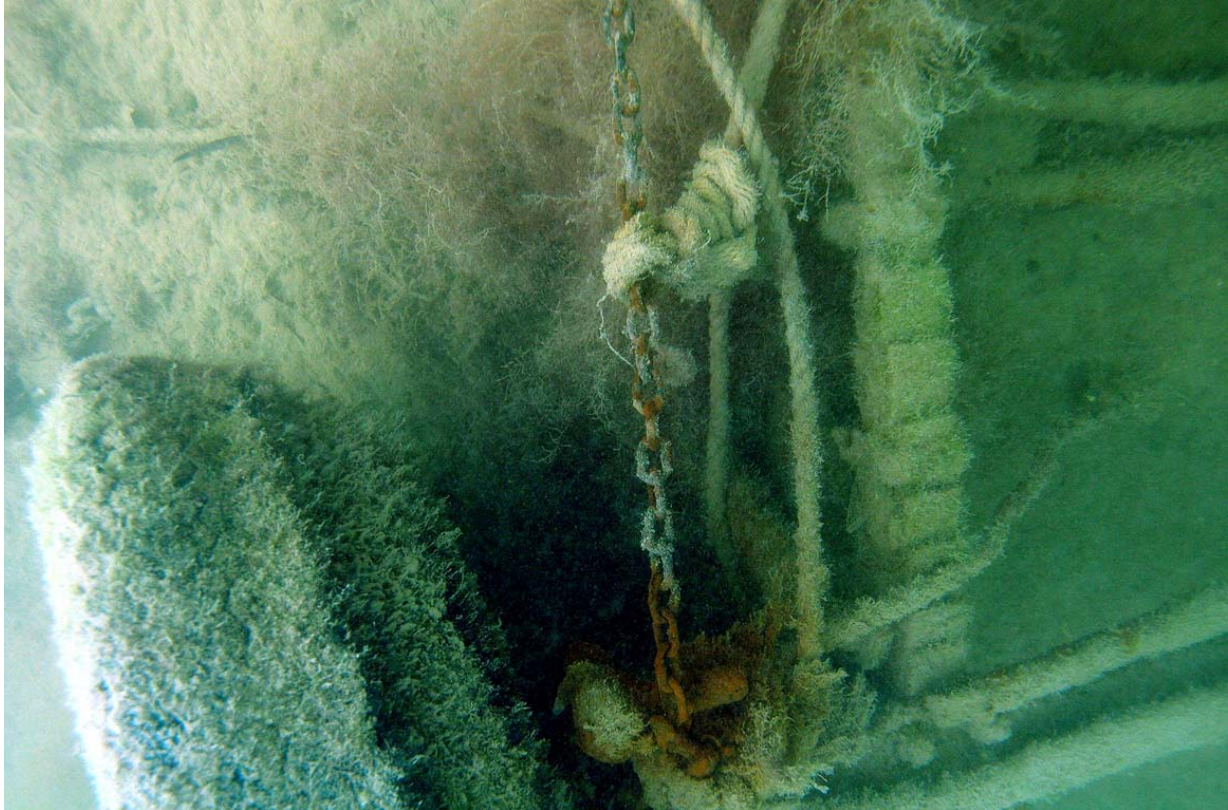
Photo of a typical debris-constructed mooring composed of portions of a vehicle frame including axels, leaf springs and tires.

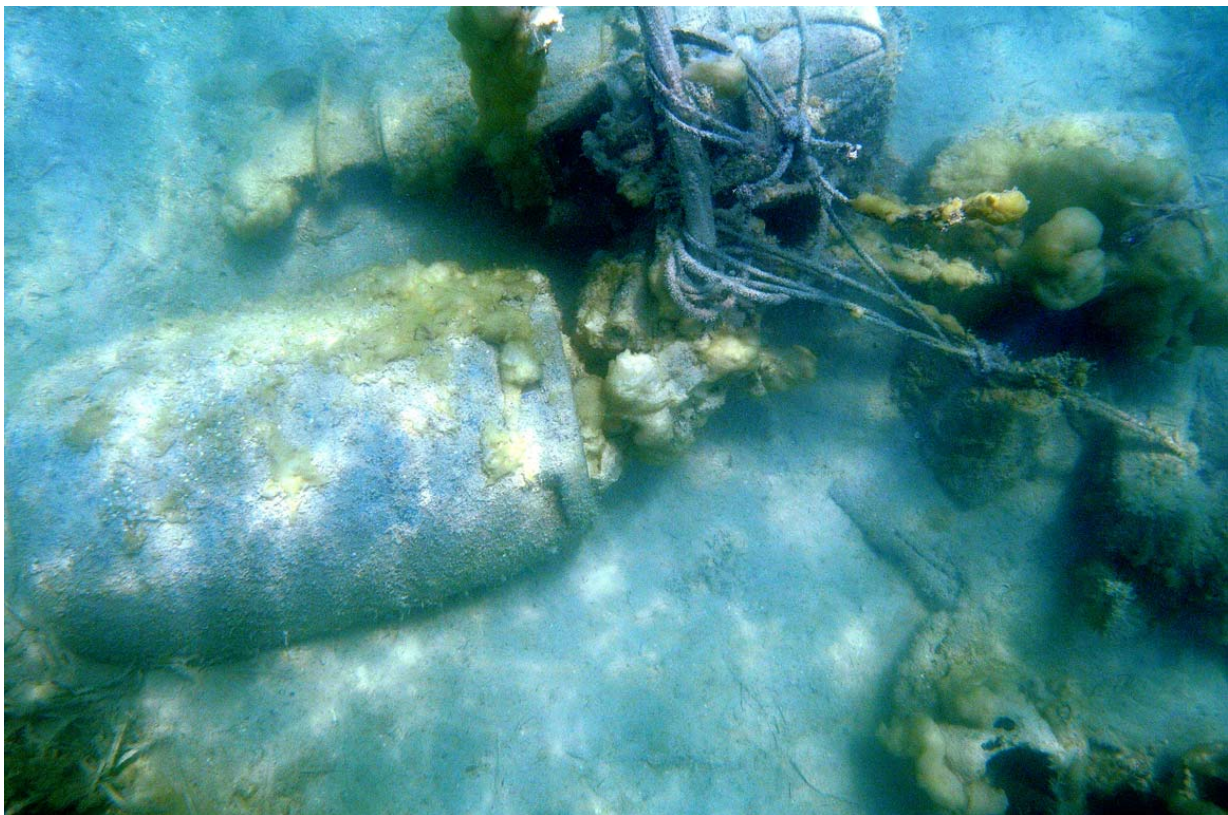
Photo of a typical debris-constructed mooring in hardbottom habitat. The concrete-filled blue drums is also a common mooring device seen throughout the mooring.

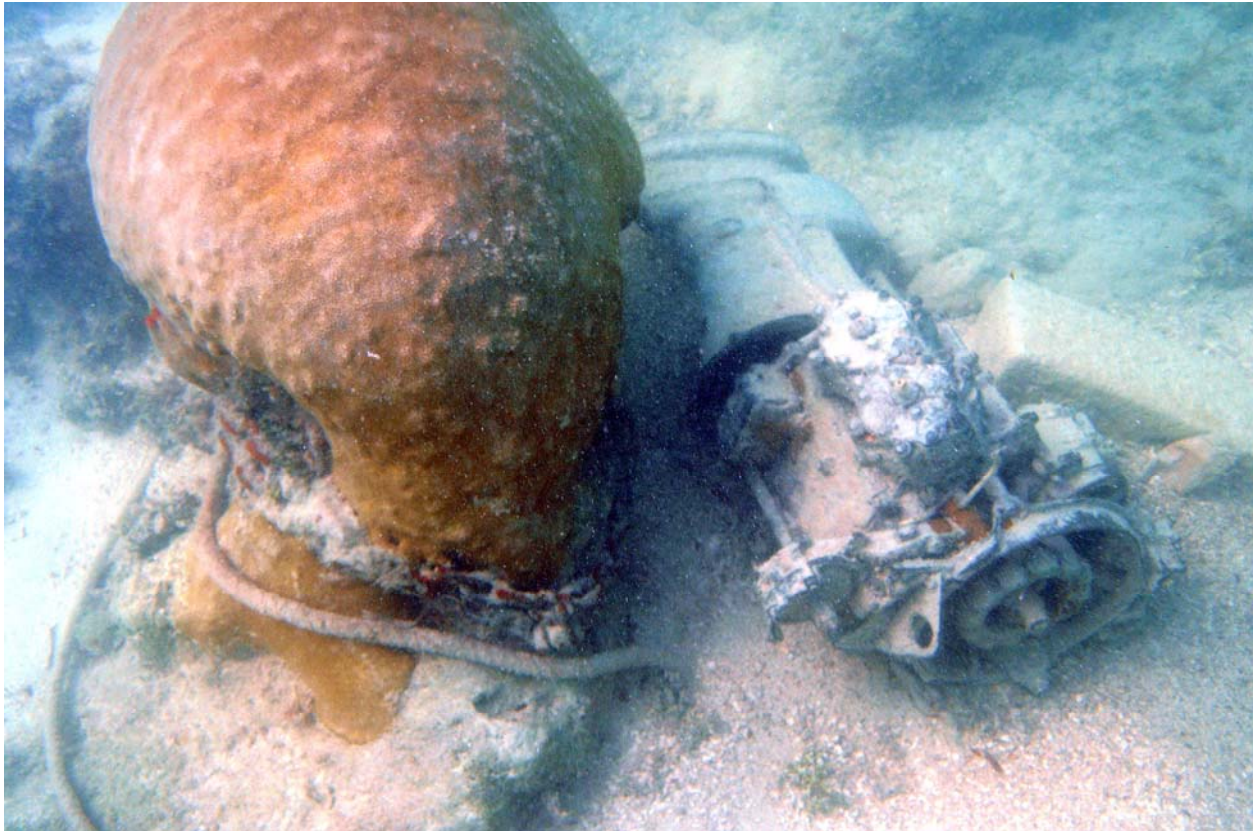
Photo of an outboard motor mooring chained to a large coral head. This mooring was clearly deliberately constructed to include the coral head as the chain is wrapped completely around the coral.

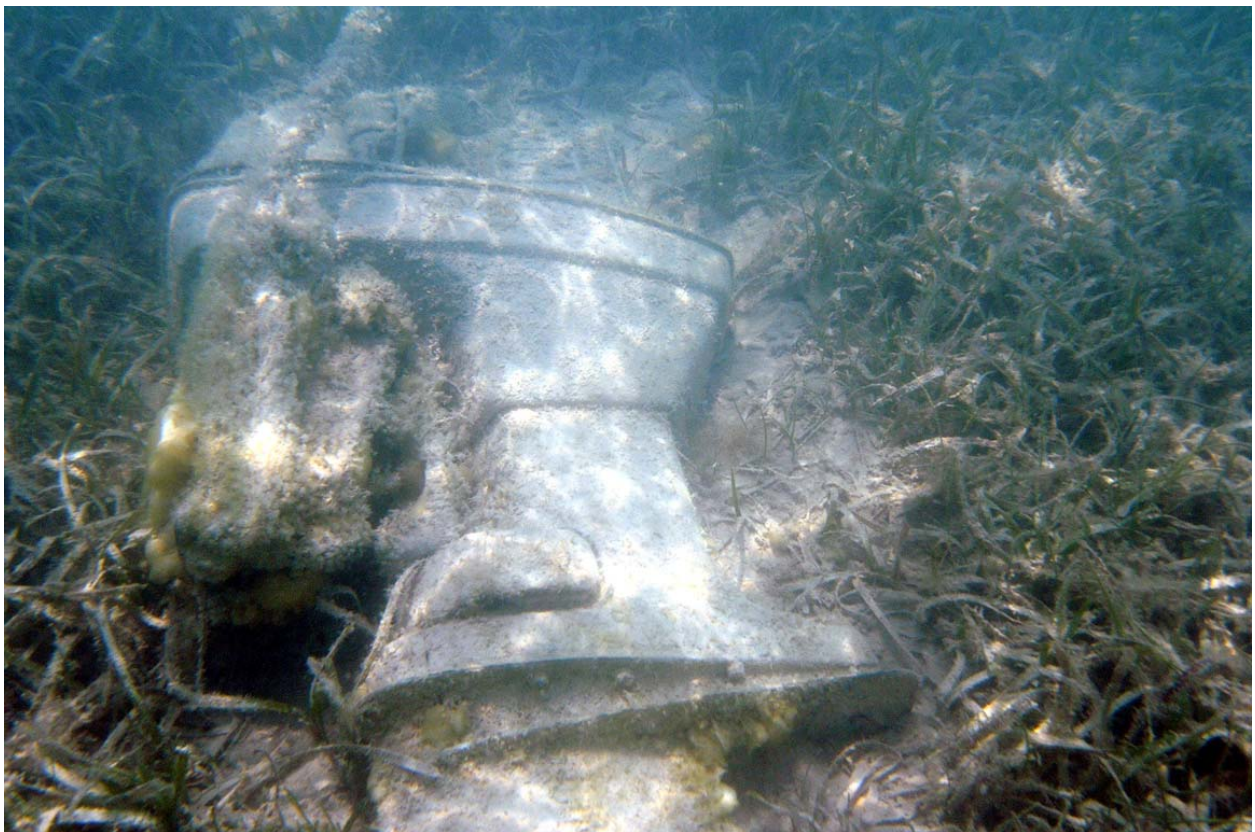
Photo of an outboard motor mooring in dense seagrass habitat. In addition to direct displacement of seagrass habitat, these mooring are prone to shift, resulting in ongoing seagrass damage.
